# **Annual Inspection Report for the Humboldt Station Former Ash Pond**

**Humbolt, Iowa**

**Corn Belt Power Cooperative**

**October 6, 2026**

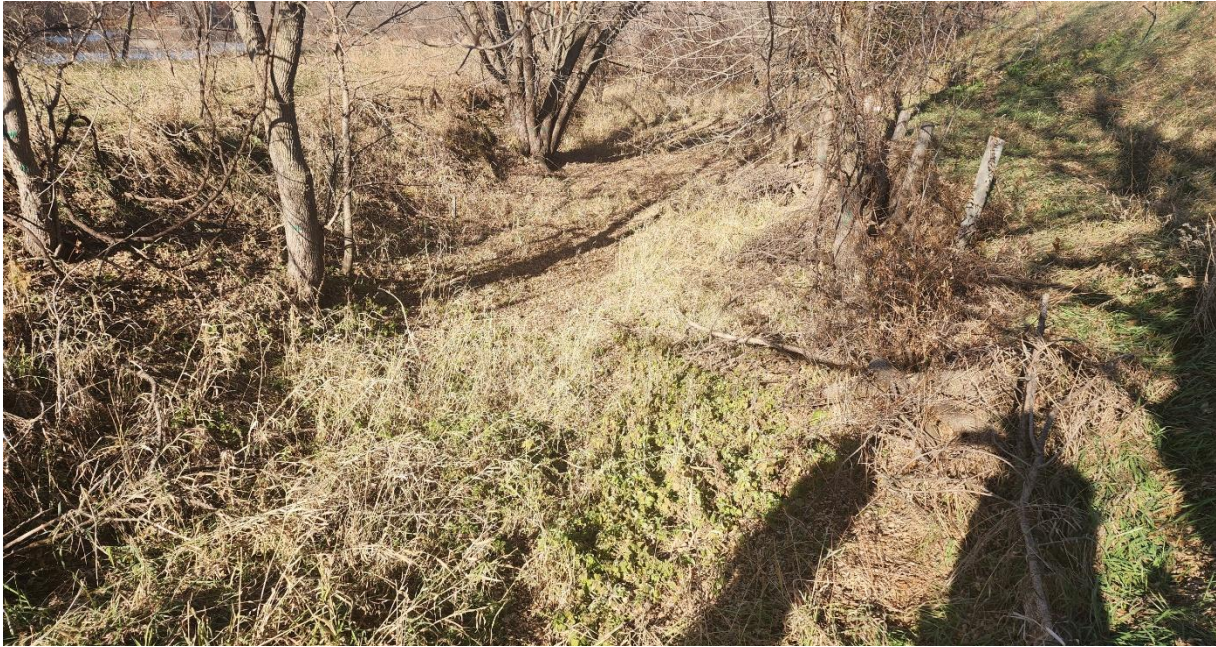
**Photo 1**      ***North end of ash pond, looking generally west.***

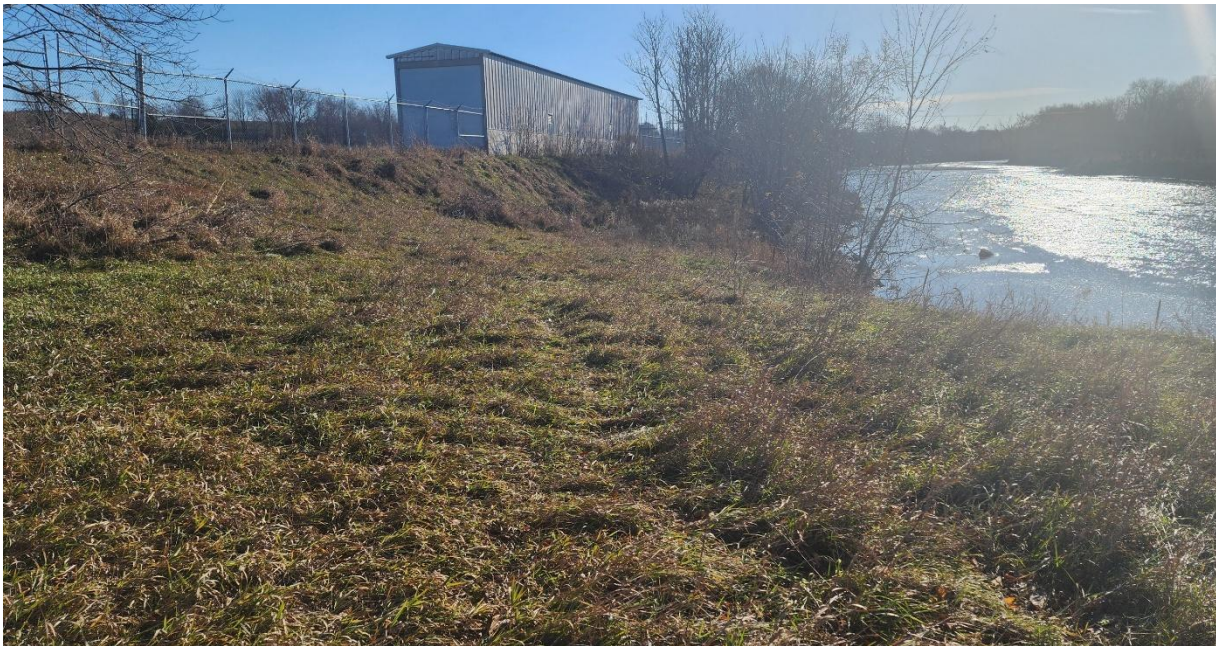
**Photo 2**      ***Grade outside north end of ash pond. Looking east.***

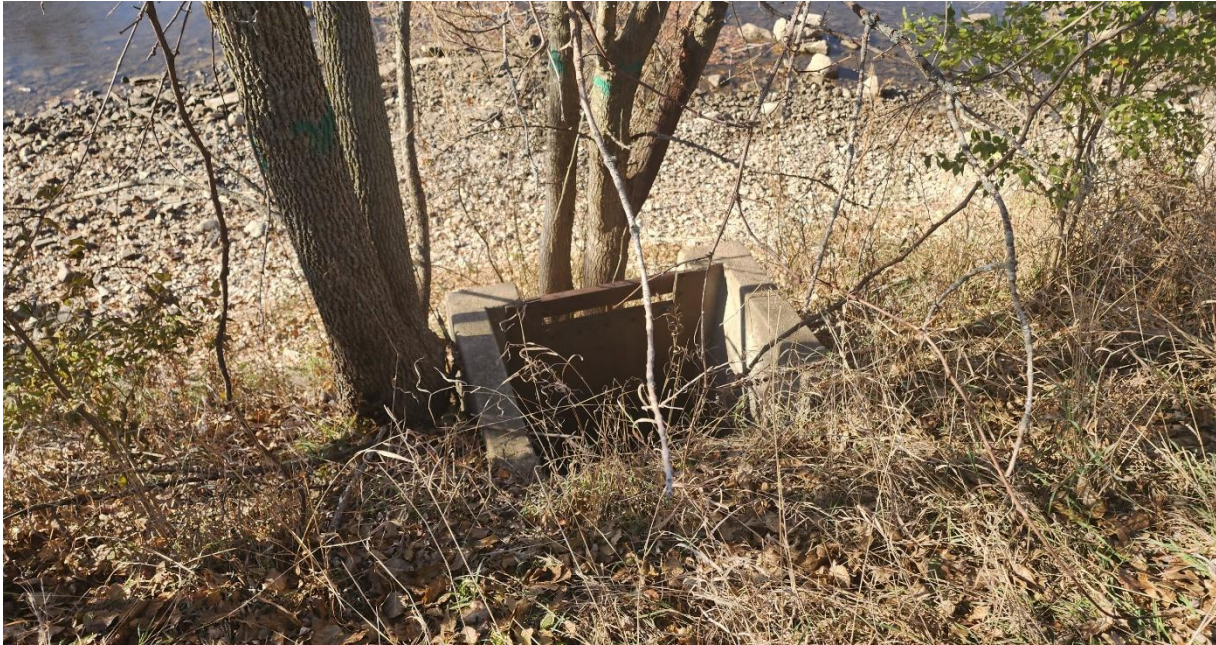
**Photo 3**      ***Former outfall structure along river bank, south of ash pond, near north end of ash pond.***

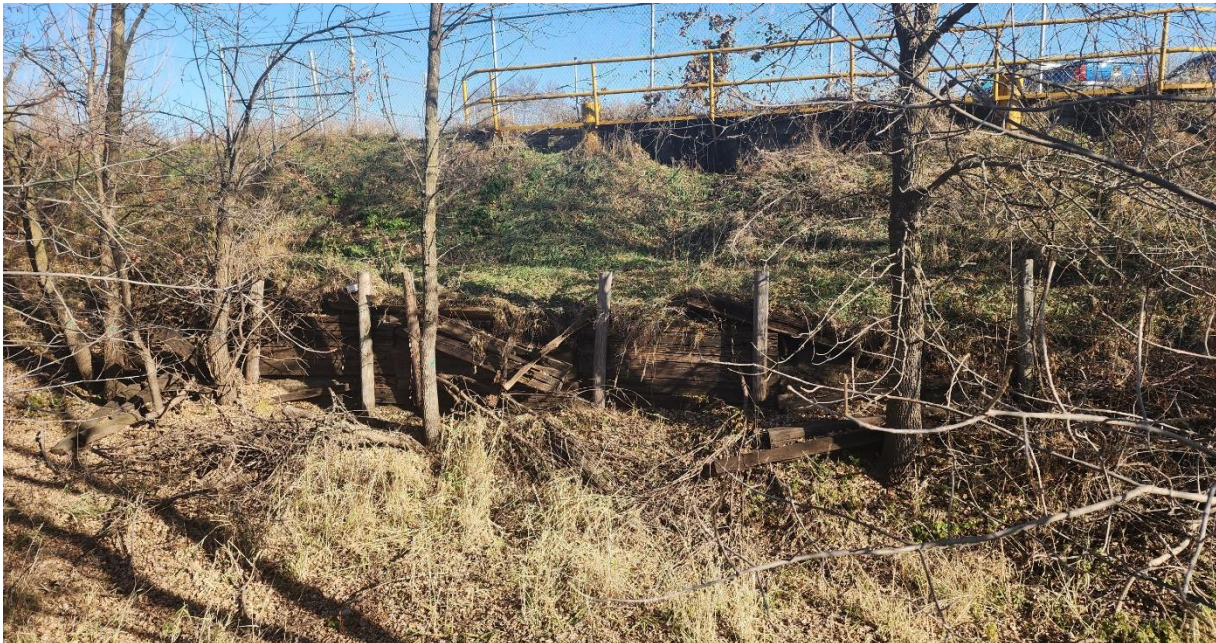
**Photo 4**      ***Support structure on north side of ash pond, viewed across the ash pond. Looking north.***

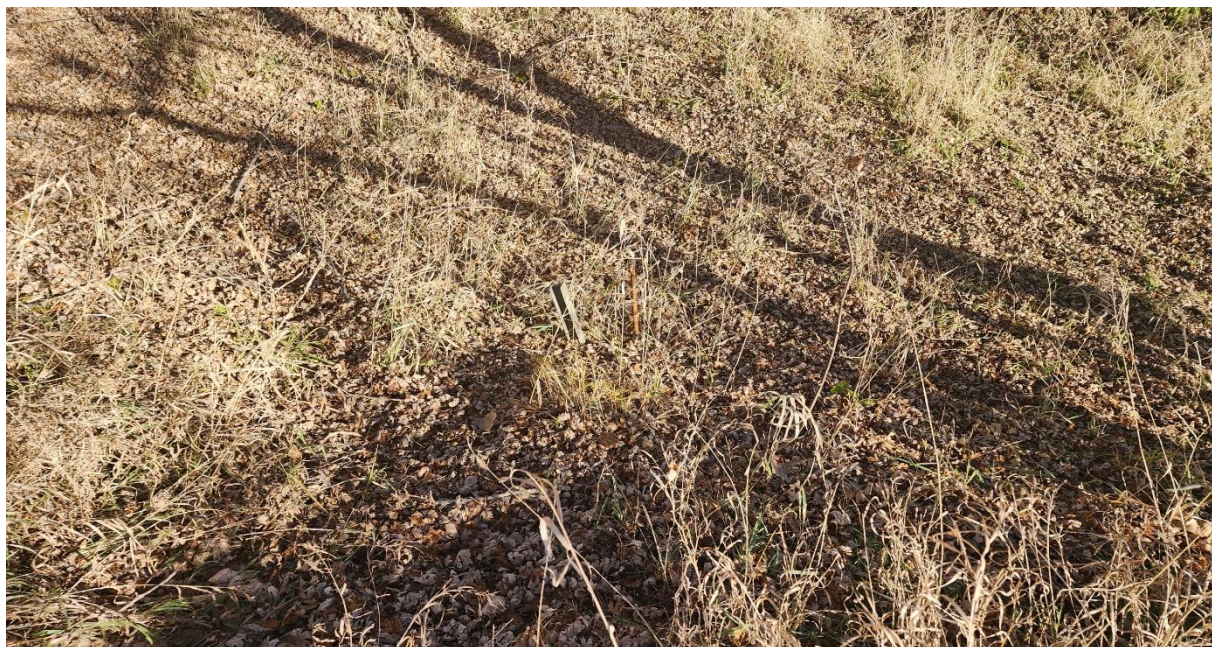
**Photo 5**      **General ground condition at north end of the ash pond. Looking north-northeast.**

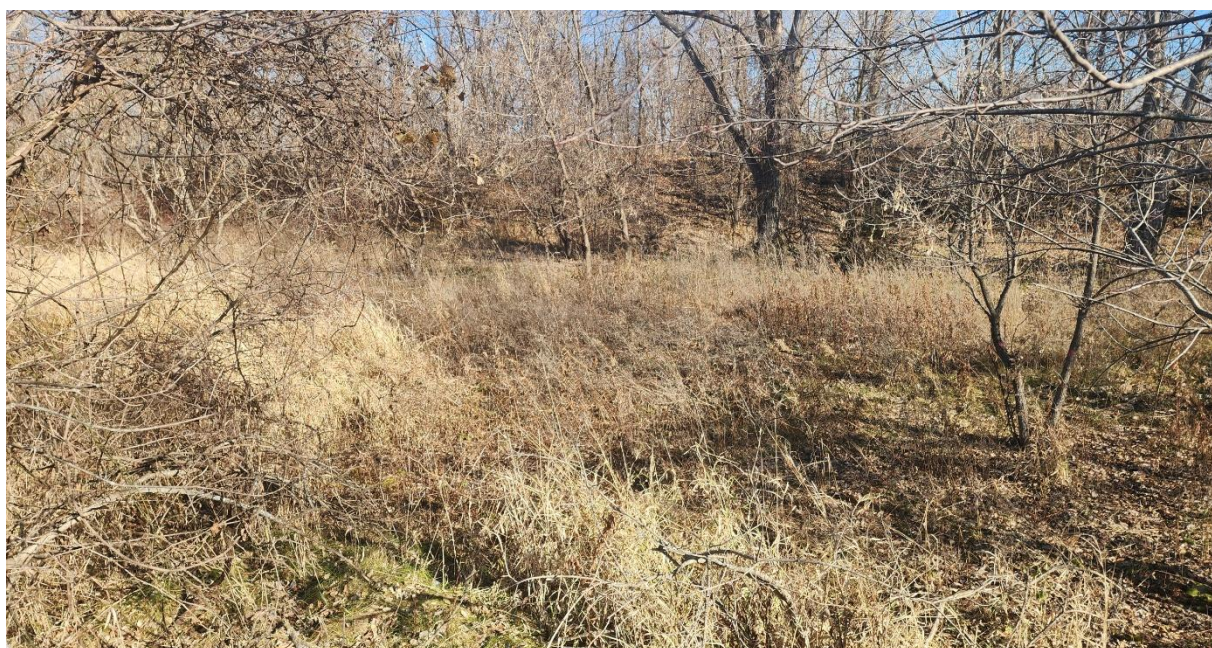
Subparagraph 40 CFR 257.83(b)(2)(vii) requires any other change(s) which may have affected the stability or operation of the impounding structure since the previous annual inspection be documented in the annual inspection report. There is heavy vegetation in the ash pond and surrounding area. The ash pond is not an active management structure so there is no impact on operations. The 2025 inspection serves as the baseline for future inspections.

**Photo 6**      **General conditions in east-central part of ash pond. Large tree in background is in the ash pond. Looking north.**

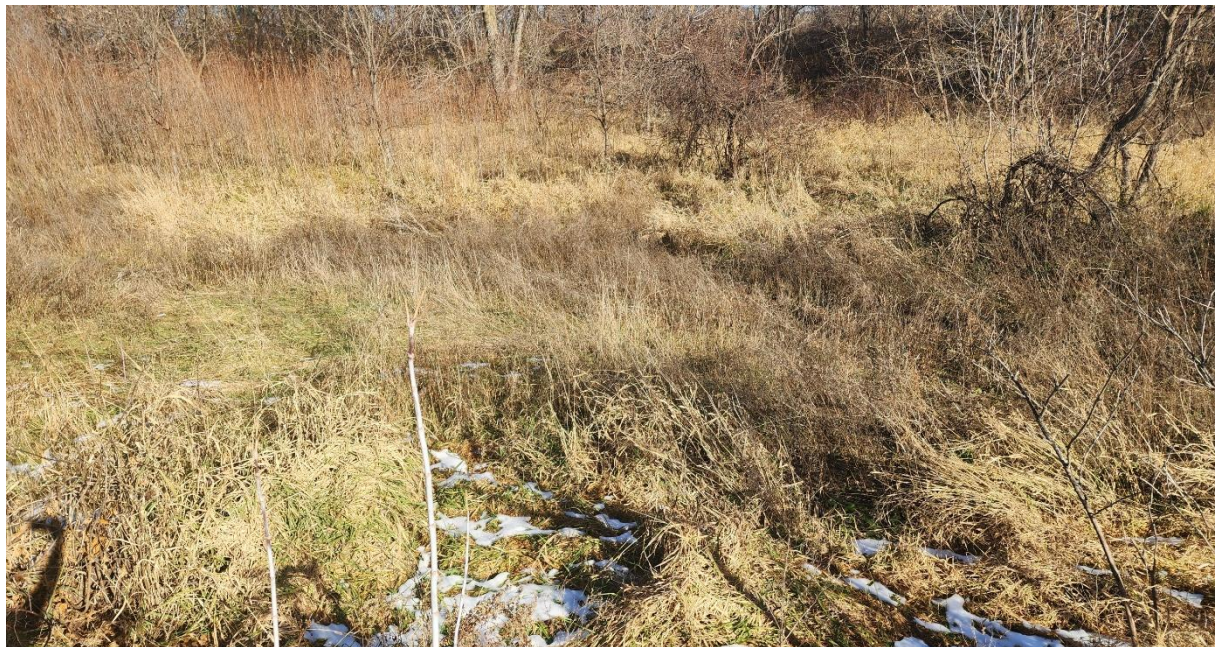
**Photo 7**      ***General ground conditions in the central area of the ash pond. Looking north.***

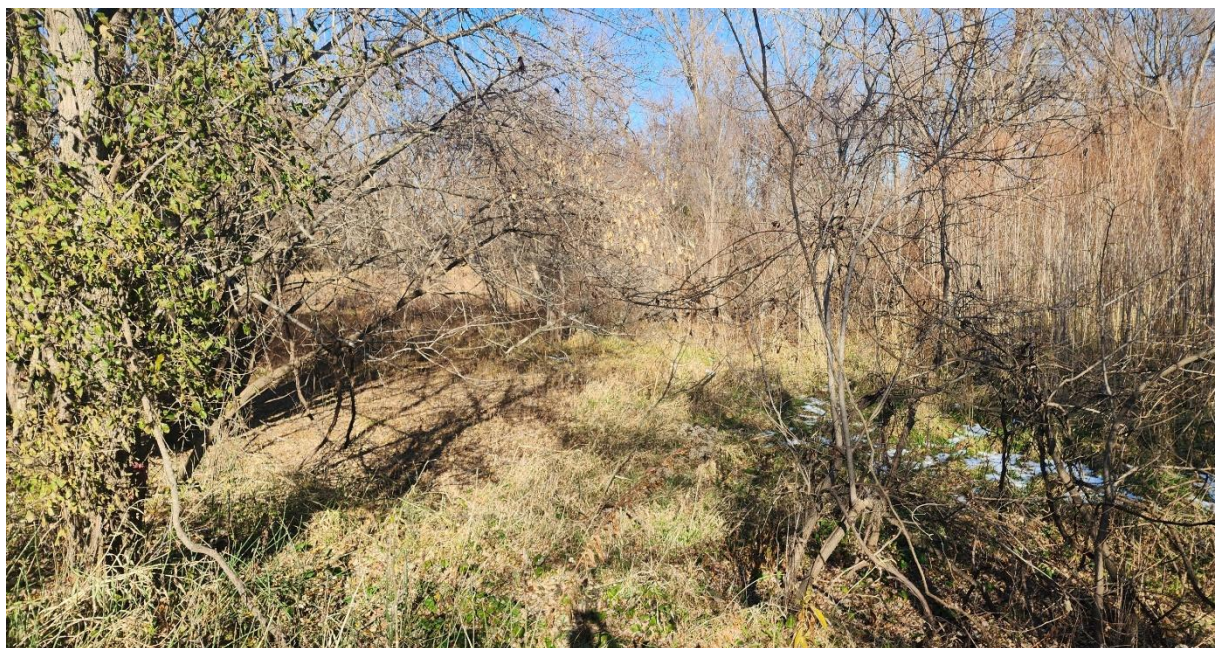
**Photo 8**      ***General conditions in the central west part of the ash pond. Looking north.***

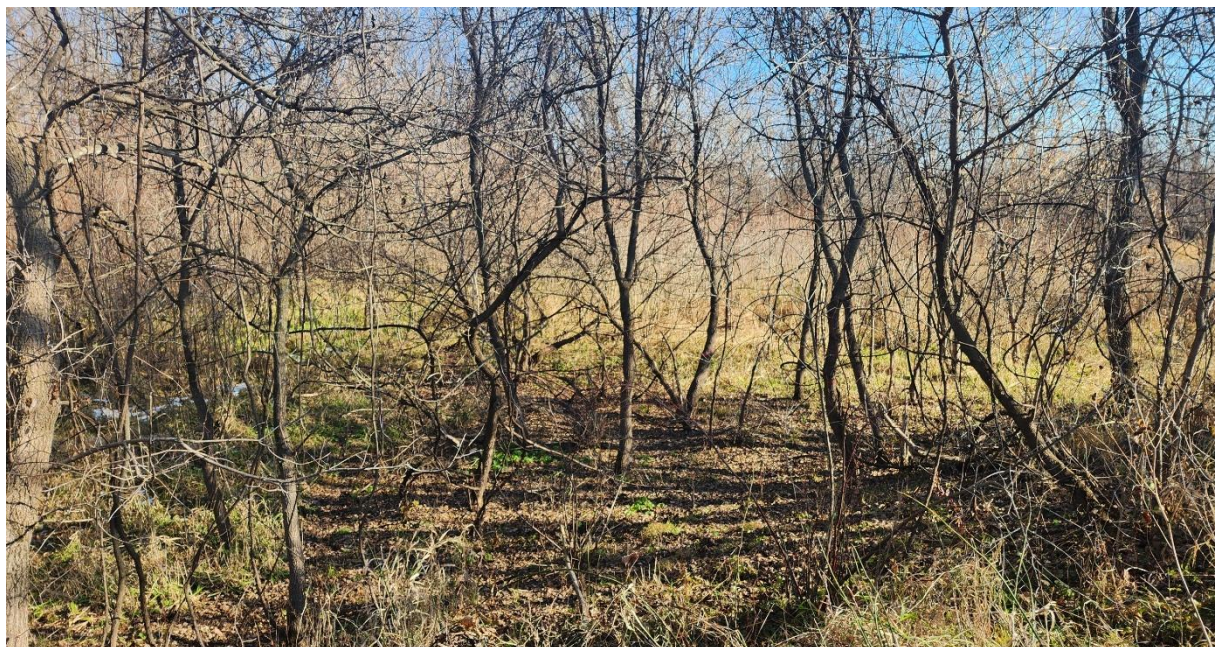
**Photo 9**      ***West end of ash pond floor. Looking northeast.***

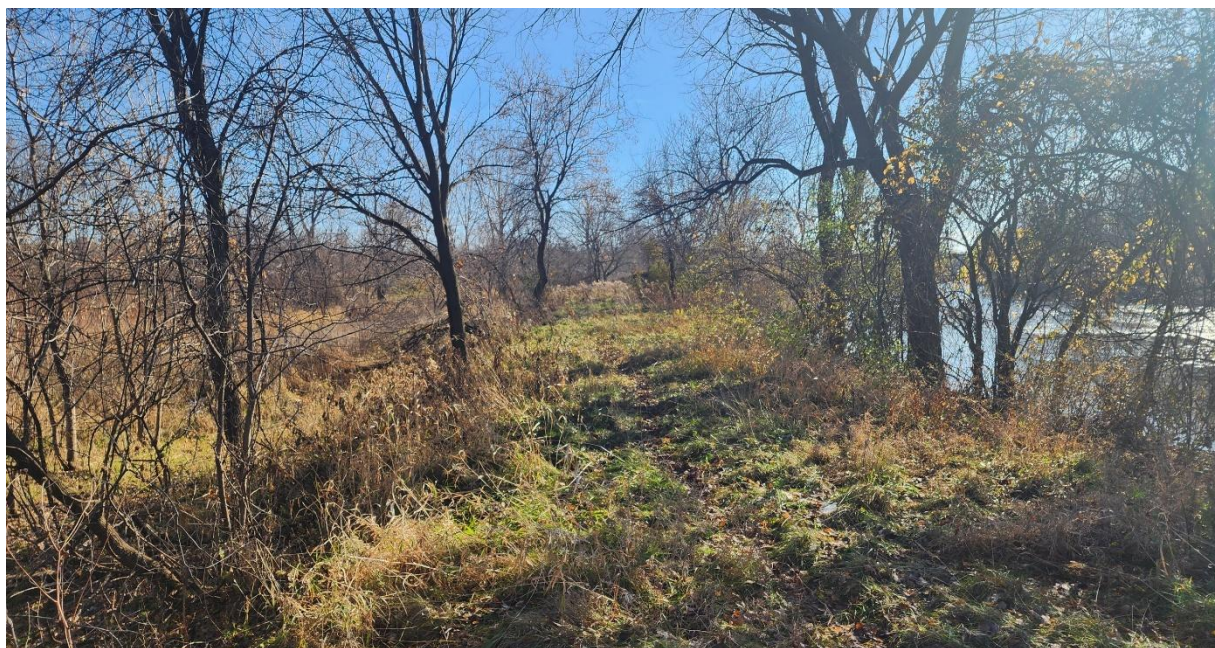
**Photo 10**      ***Access road at west end of the ash pond. Looking east.***
